Property Condition Assessment

Property Address:
1234 X Line
AnyCity, ON

Technominds Inspection Services Inc.

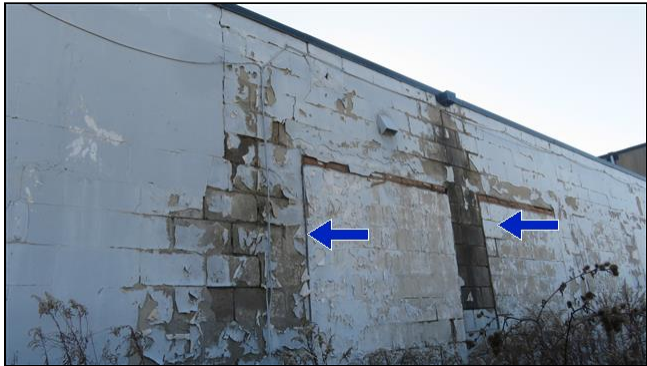
2.1 Water damages and Spalling of concrete blocks on North side, due to defective roof water drainage. Further deterioration can occur if not corrected, recommended to be fixed/replaced as required.

Time Frame: 0-1 Year

Cost: Upto \$3-5K

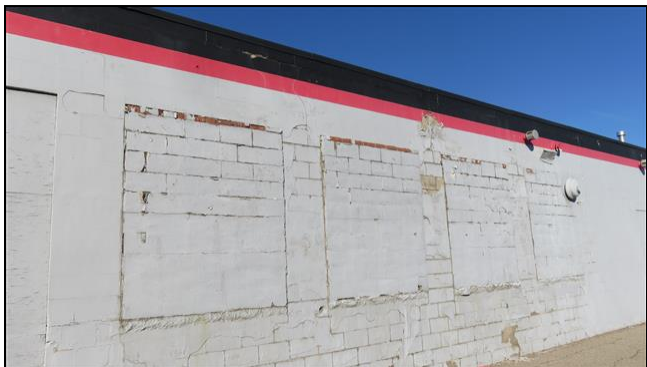
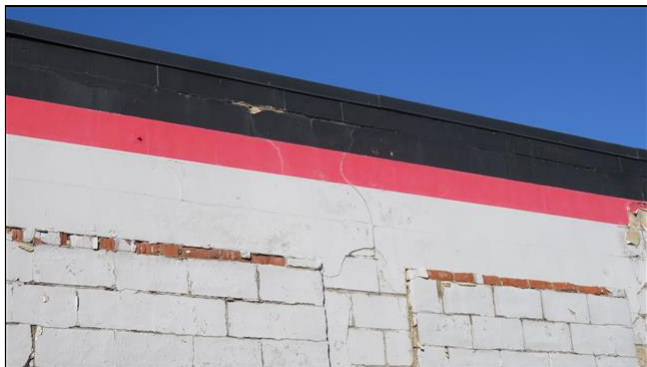
2.1 Condition: Missing mortar in concrete block siding on South sides of the building, above grade.

Task: To be fixed to prevent water penetration and further damages.

Time Frame: Within next 1 Year

Cost: Upto \$3K

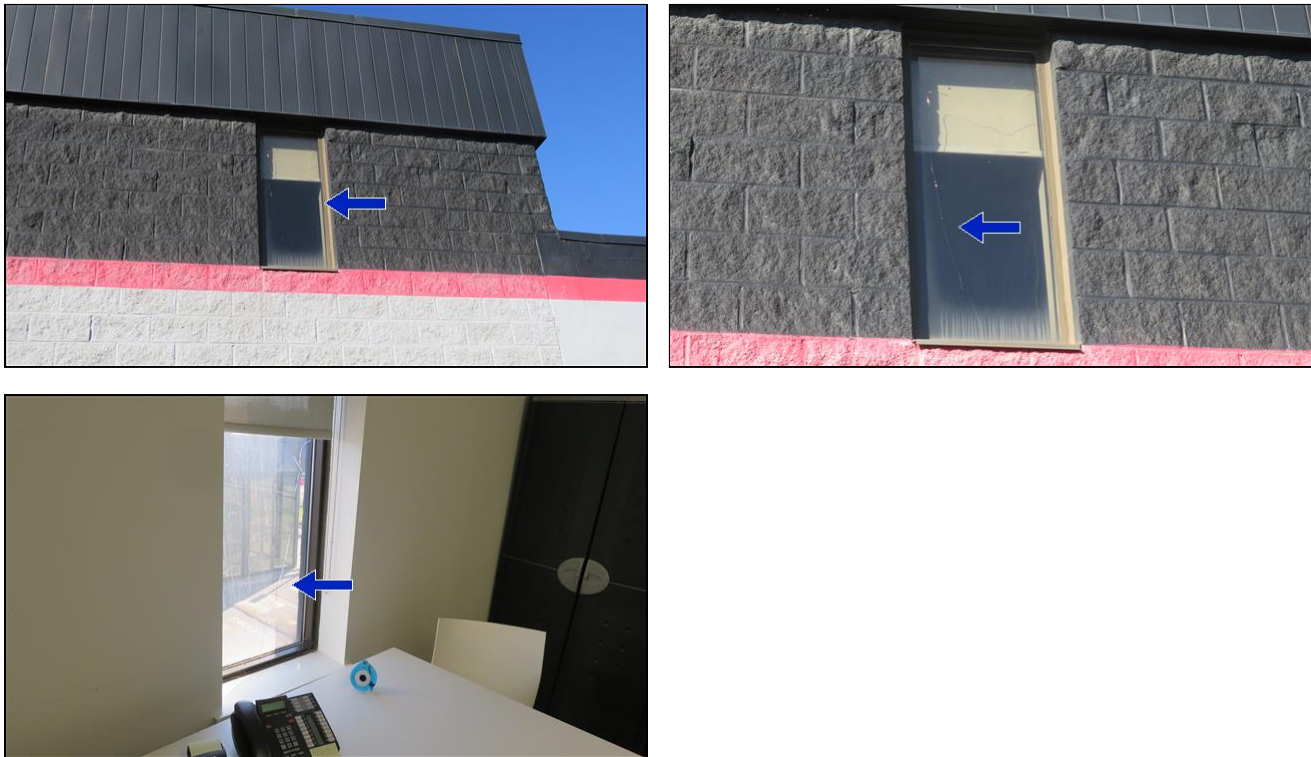
2.6 Condition: Exterior window glass pane broken for upstairs office area.

Task: To be installed/replaced, to prevent heat loss.

Time Frame: Within next 3 Months

Cost: Minor, \$500-1000.

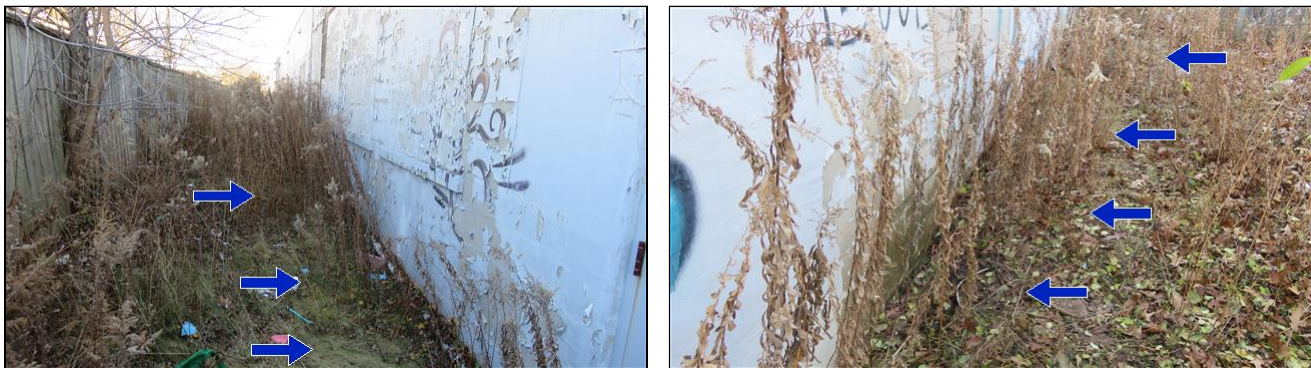
2.7 Condition: Grading conditions were poor with negative slope on North side, can cause or contribute to water intrusion or deterioration to building.

Task: Grading needs to be corrected to drain water away from the building.

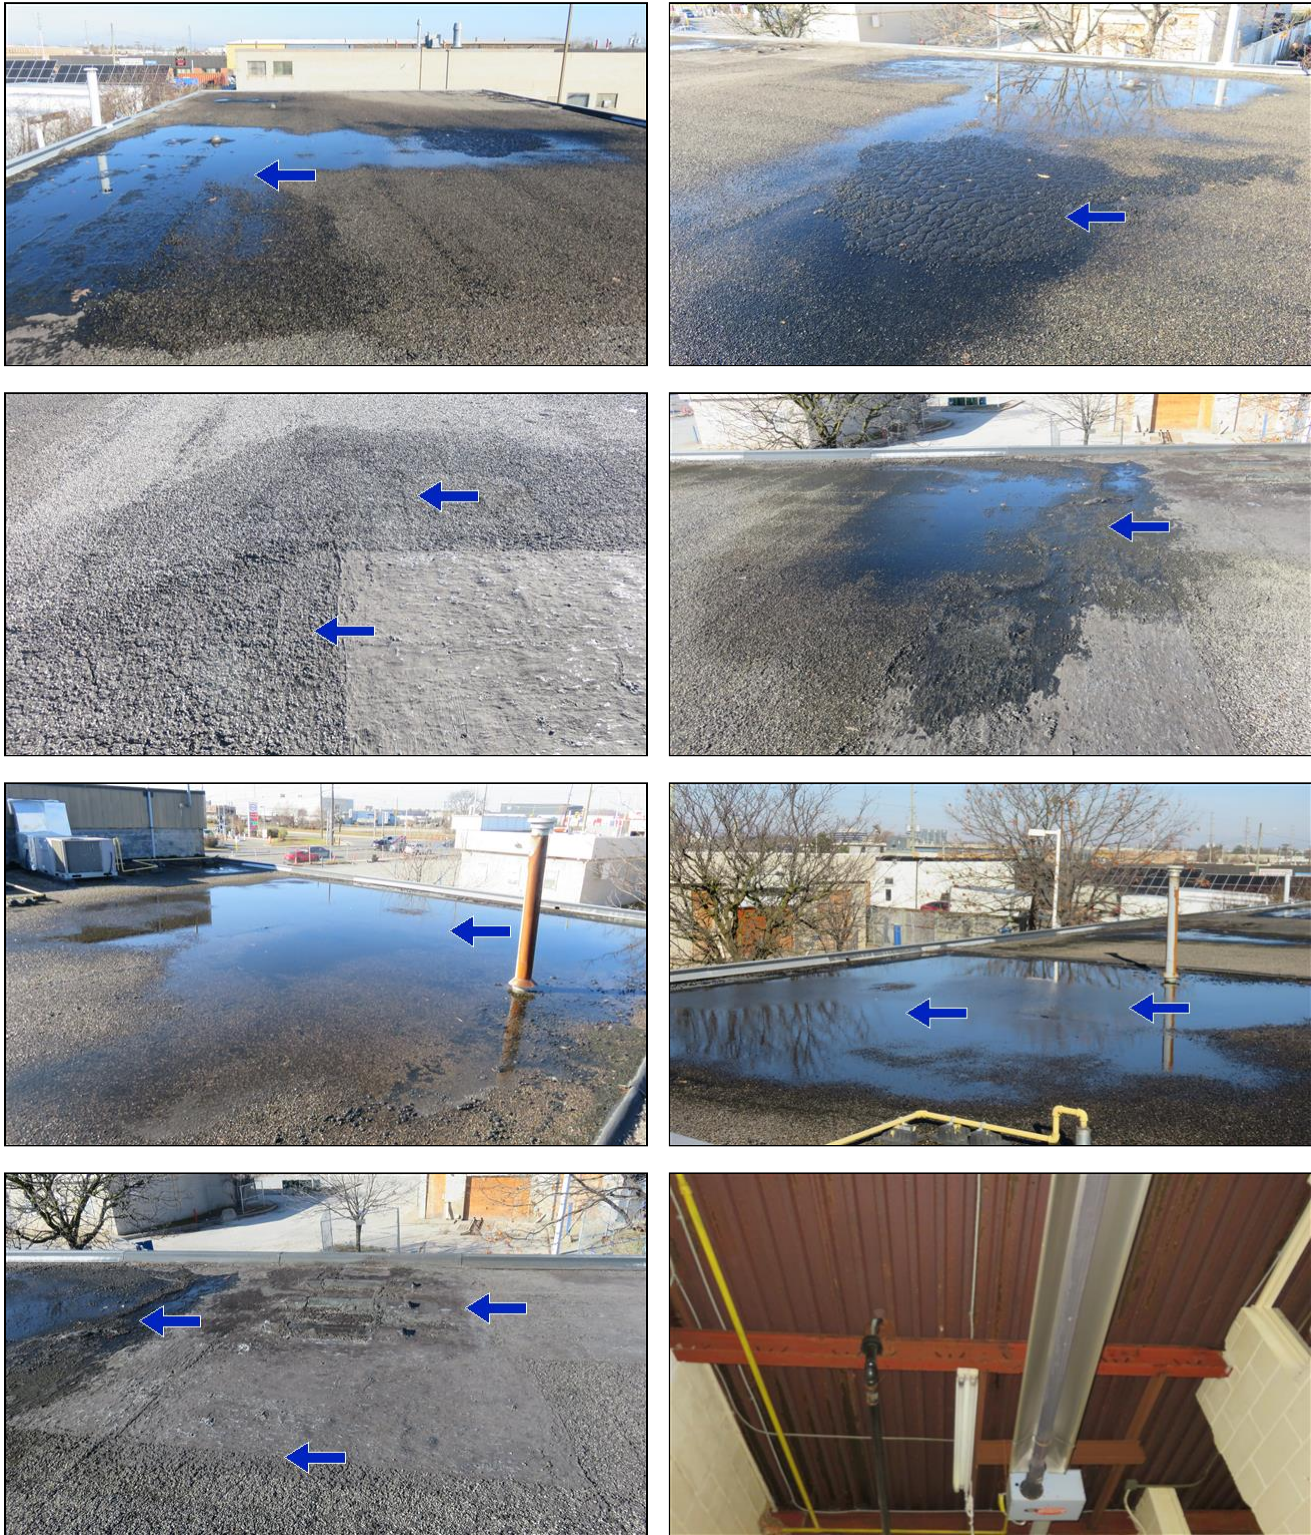
Rust due to Leakage

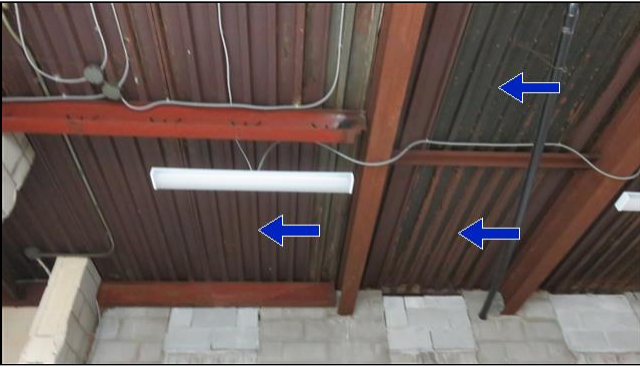
Rust Due to Leakage

3.0 Roof General Condition: Roof drainage was blocked, causing standing water on the roof. Sign of roof leaks at some places inside the building. A considerable amount of deferred maintenance was noted.

Recommendations: Roof covering may need repair or replacing immediately, recommended to be further evaluated by certified roofer at the earliest possible.

Estimated Cost: \$ 10K - 15K, If needs repair
Detailed quotation reqd, if needs replacement.

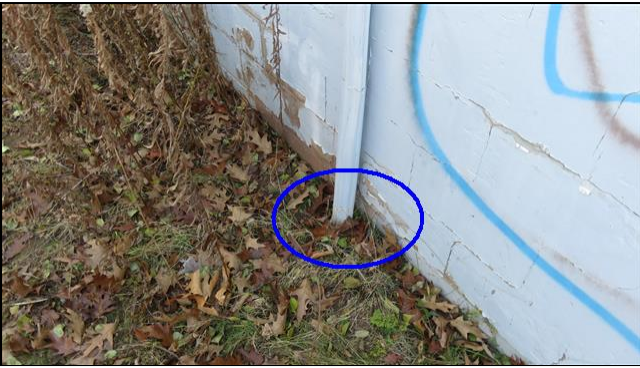
3.5 Condition: The below ground drain lines for roof downspouts were old and overloading due to the buried drainage system. Due to its age I am unable to determine if drains will function properly.

Task: Roof drainage recommended to be drained above the grade.

Time Frame: 0-1 Years

Estimated Cost: Minor, below \$ 3000

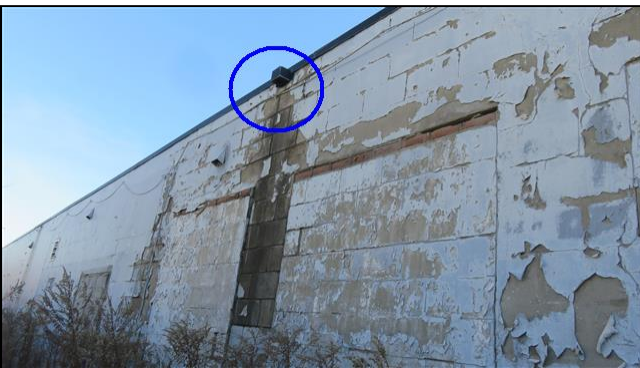
3.5 Downspout missing on North side, causing water damages to the exterior wall.

Roof downspout needs to be installed and continued with concrete splash drive for proper drainage and prevention of water flow towards foundation wall.

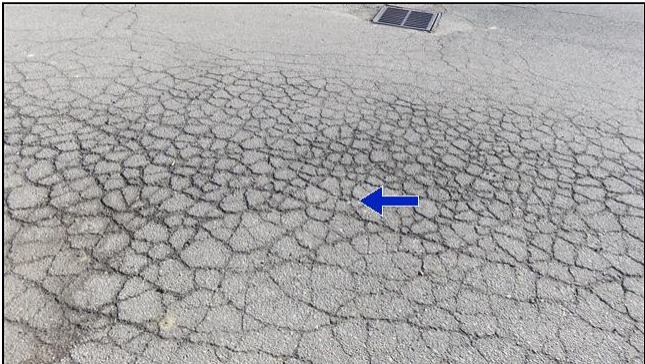
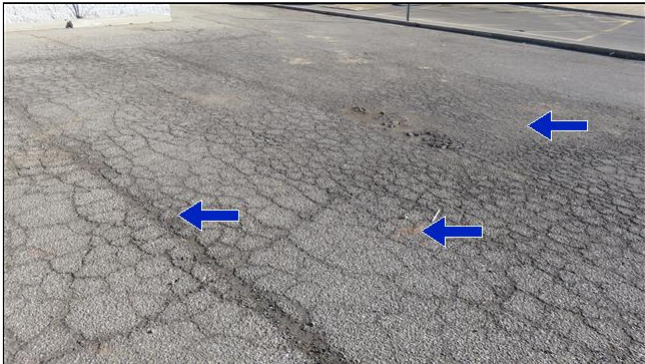
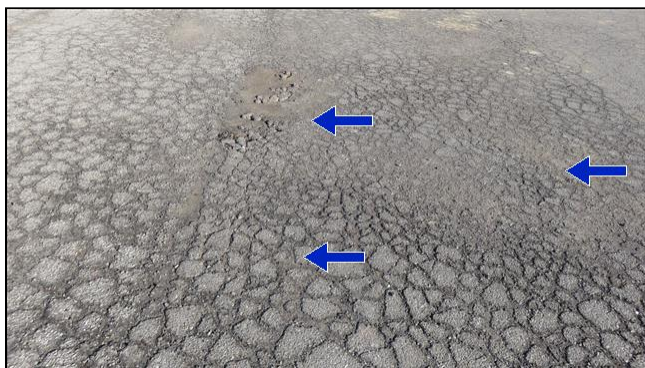
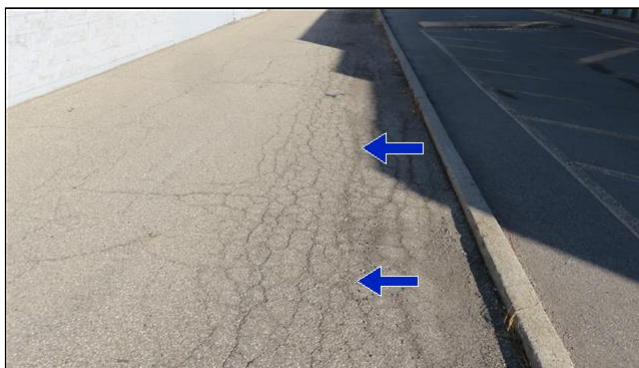
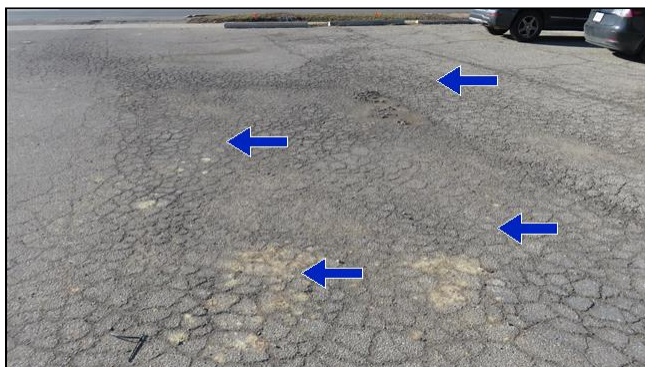
4.1 Parking Lot Condition: The parking lot and driveway at front and back were in poor condition with shrinkage cracks and potholes. The asphalt pavement is aging and renewal is expected shortly.

Level of Maintenance: Deferred maintenance has been noted.

Implications: Deteriorated asphalt may become unusable for vehicles and unsafe for pedestrians.

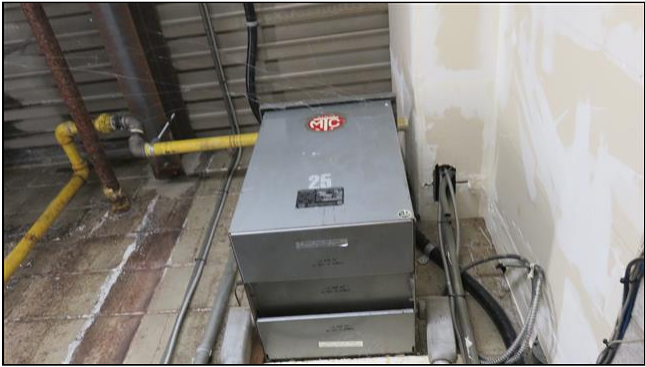
7.5 25 KVA - three phase transformer was located in the electrical room.

These are for use by process equipment and are beyond the scope of this assessment.

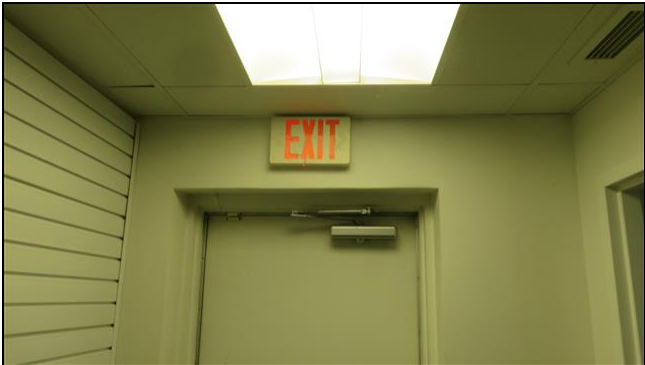
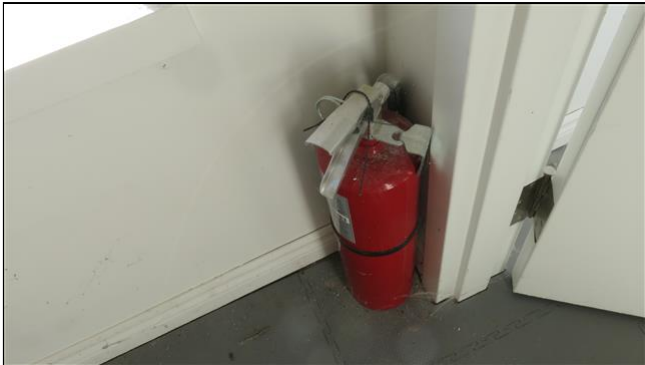
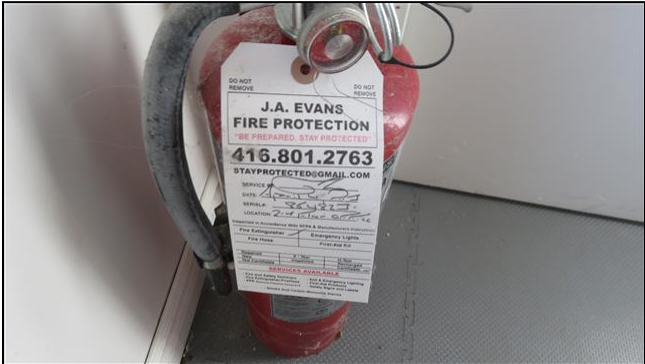
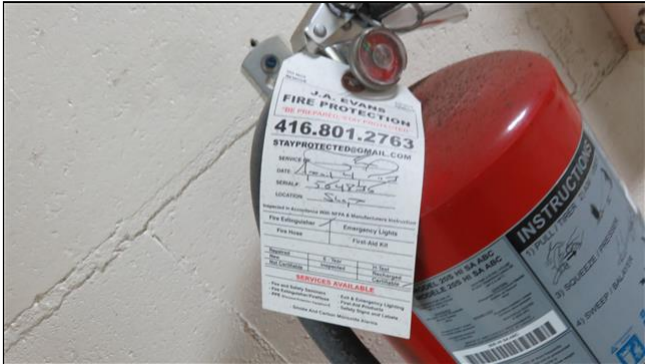
7.9 **General:** Exit signs/emergency lighting system was in working condition at exits. The attached pictures indicate that the current report for fire & safety was done in April, but the year mentioned was not clear.

Recommendations: Current Annual Fire Safety and compliance report recommended to be collected from the owner/seller.

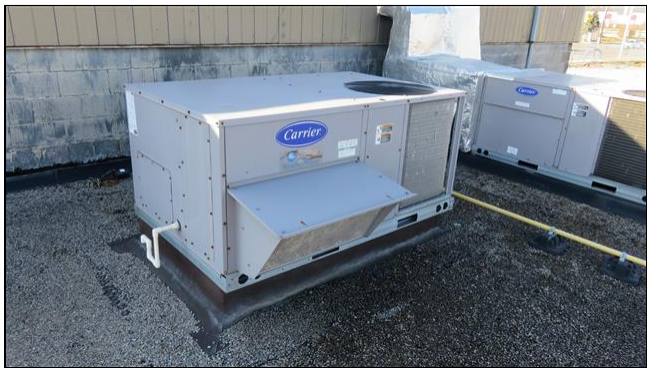
9.1 Rooftop Units - General: Two dedicated rooftop unit serving the office and retail area.

Typical Rooftop Unit life expectancy: 20 years.

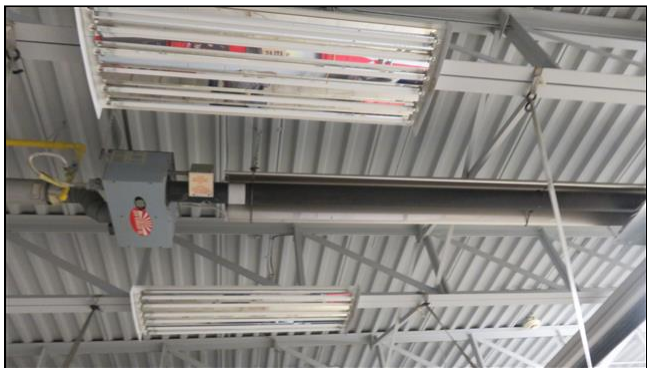
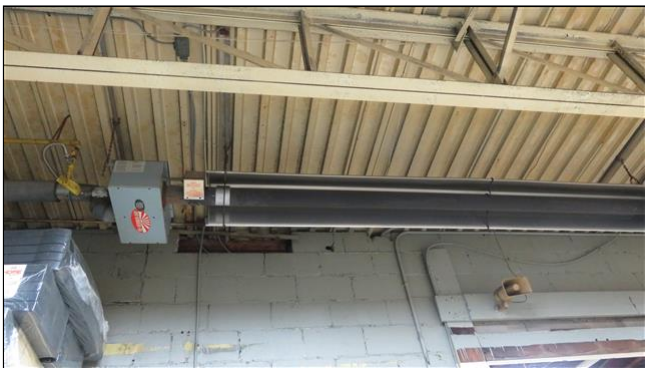
9.4 Two Radiant gas heaters not in working condition, thermostats not working when tested, in workshop area.
Recommended to be fixed or replaced as required.

Estimated Cost: \$3K-5K
