Inspection Report

Property Address:
123 Main St
Anycity, ON

Technominds Inspection Services Inc.

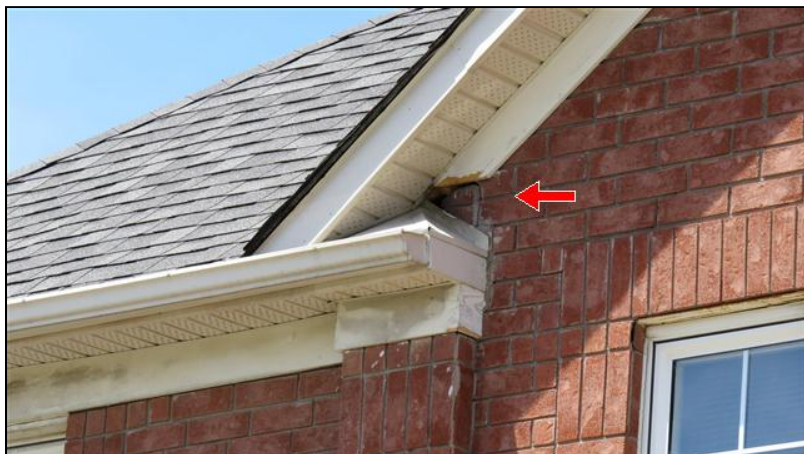
2.0 Damage in brick siding near soffit on South side, needs to be fixed to prevent rodents, birds and other pests to enter to attic area.

2. Damage in brick siding near soffit on South side, needs to be fixed to prevent rodents, birds and other pests to enter to attic area.

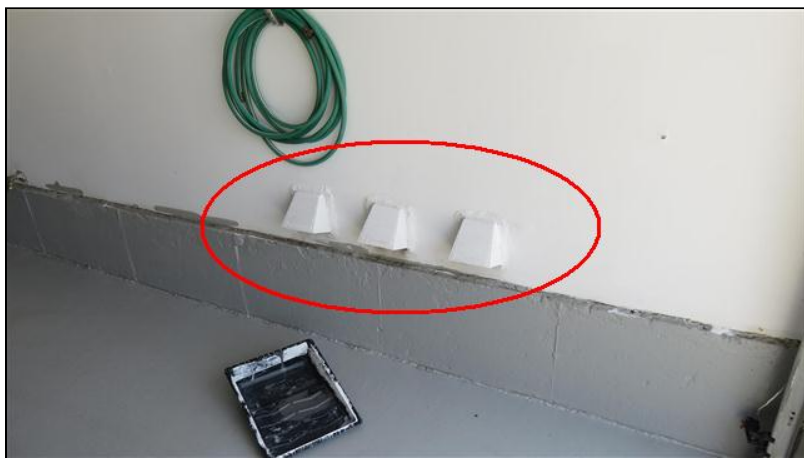
3.2 The fire protection wall in garage is compromised by leaving basement exhaust vents in garage. This is considered unsafe until corrected. A qualified person should correct for safety.

4. The fire protection wall in garage is compromised by leaving basement exhaust vents in garage. This is considered unsafe until corrected. A qualified person should correct for safety.

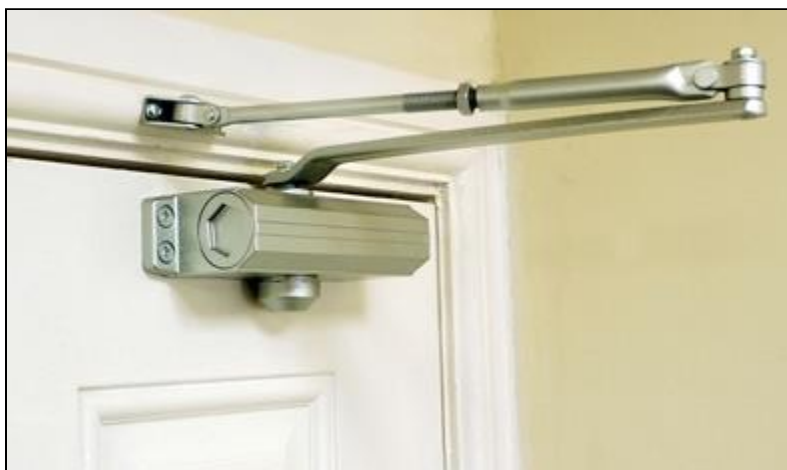
3.3 Garage door (to dwelling unit) hydraulic door closer missing, needs to be installed. Self closing is a requirement for proper gas separation (carbon monoxide from car fumes) and for fire separation.

5. Garage door (to dwelling unit) hydraulic door closer missing, needs to be installed. Self closing is a requirement for proper gas separation (carbon monoxide from car fumes) and for fire separation.

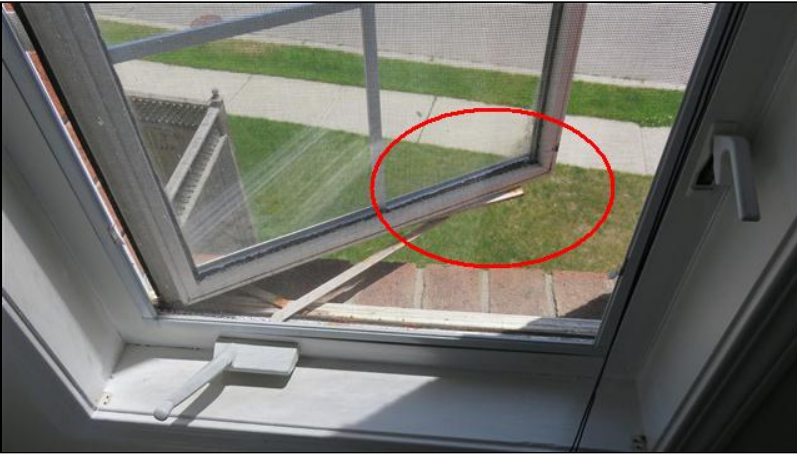
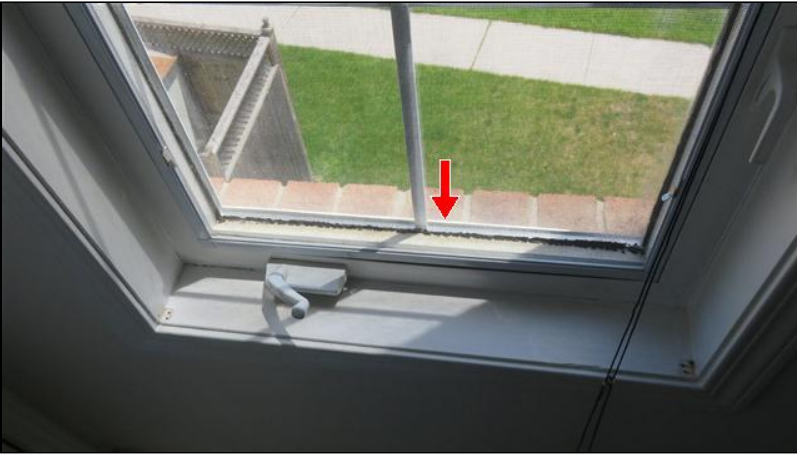
4.5 Upstairs Jack & Jill bathroom window with sign of condensation and damaging thermal seal. The glazing between glass panes are failing at this window, needs to be replaced.

6. Upstairs Jack & Jill bathroom window with sign of condensation and damaging thermal seal. The glazing between glass panes are failing at this window, needs to be replaced.

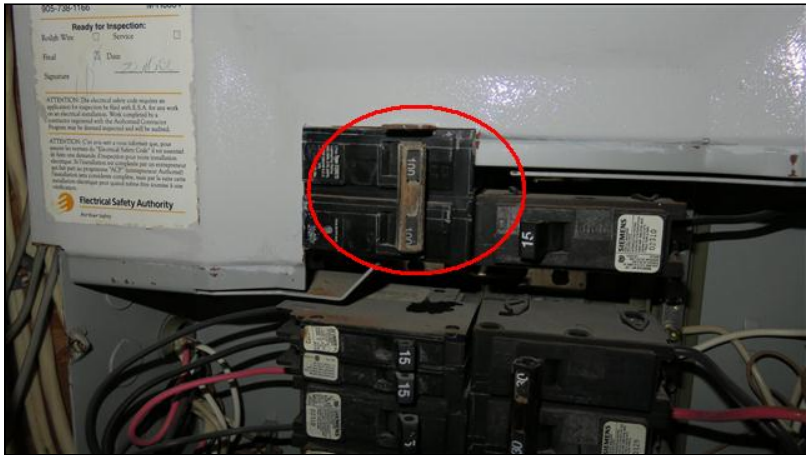
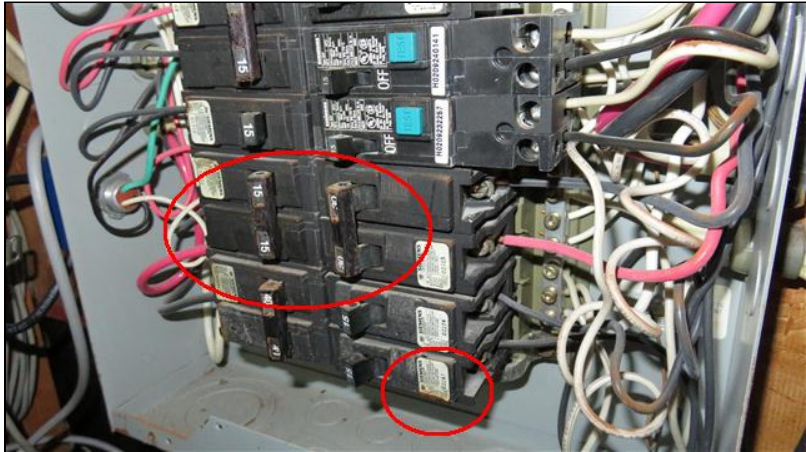
6.2 Sign of rust and burns in electrical panel, unsafe and fire hazard. Needs to be further evaluated by Certified Electrician.

6.2 Due to overloading/renovation of additional dwellings with separate laundry in basement, further evaluation by Certified Electrician is recommended to upgrade amperage of main service from 100 to 200 Amps, as 100 Amp is the minimum requirement for single dwelling.

6.2 Branch circuits not labeled or identified. Labeling of branch circuits at main panel is recommended to be completed, its a requirement.

8. Sign of rust and burns in electrical panel, unsafe and fire hazard. Needs to be further evaluated by Certified Electrician.
9. Due to overloading/renovation of additional dwellings with separate laundry in basement, further evaluation by Certified Electrician is recommended to upgrade amperage of main service from 100 to 200 Amps, as 100 Amp is the minimum requirement for single dwelling.
10. Branch circuits not labeled or identified. Labeling of branch circuits at main panel is recommended to be completed,its a requirement.

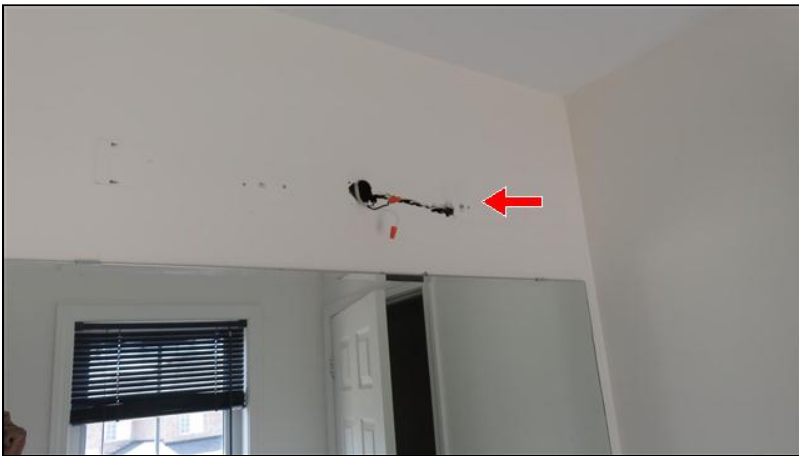
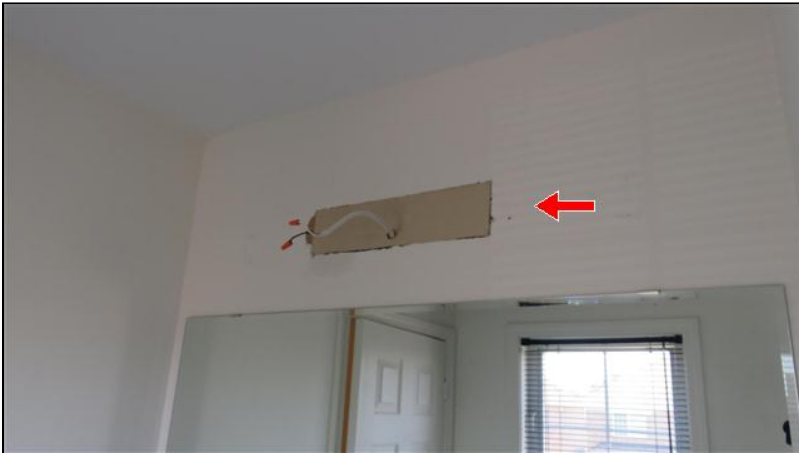
6.3 Upstairs Jack & Jill bath vanity lights missing (left with loose wiring connections), unsafe, needs to be installed.

11. Upstairs Jack & Jill bath vanity lights missing (left with loose wiring connections), unsafe, needs to be installed.

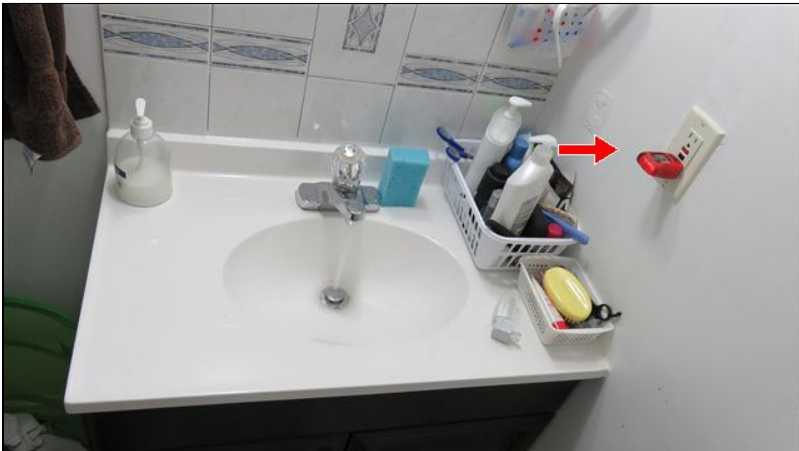
6.4 Basement washroom GFCI not in working condition when tested, unsafe, needs to be replaced at the earliest possible.

12. Basement washroom GFCI not in working condition when tested,unsafe, needs to be replaced at the earliest possible.

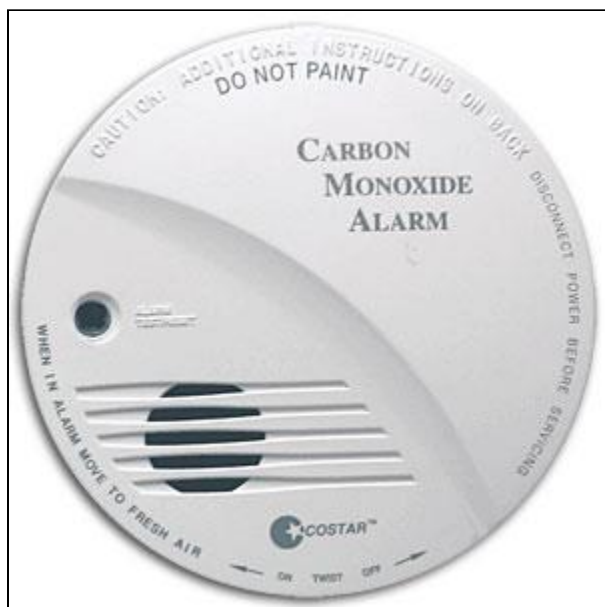
6.6 There was no carbon monoxide detector found in home, safety hazard. Any gas appliance can be a source of carbon monoxide, a dangerous gas that deprives the body of oxygen, resulting in serious injury or death. It is strongly recommended that one be installed (without any delay) at each floor level according to the manufacturer's instructions.

Testing and maintenance of Smoke & Carbon Monoxide Detectors is recommended on monthly basis.

13. There was no carbon monoxide detector found in home,safety hazard. Any gas appliance can be a source of carbon monoxide, a dangerous gas that deprives the body of oxygen, resulting in serious injury or death. It is strongly recommended that one be installed (without any delay) at each floor level according to the manufacturer's instructions.
Testing and maintenance of Smoke & Carbon Monoxide Detectors is recommended on monthly basis.

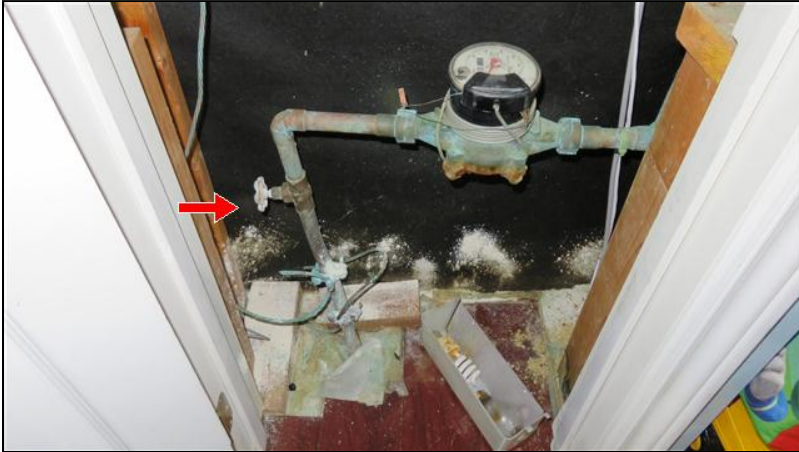
7.3 Main water shut-off is located near electrical panel in basement.

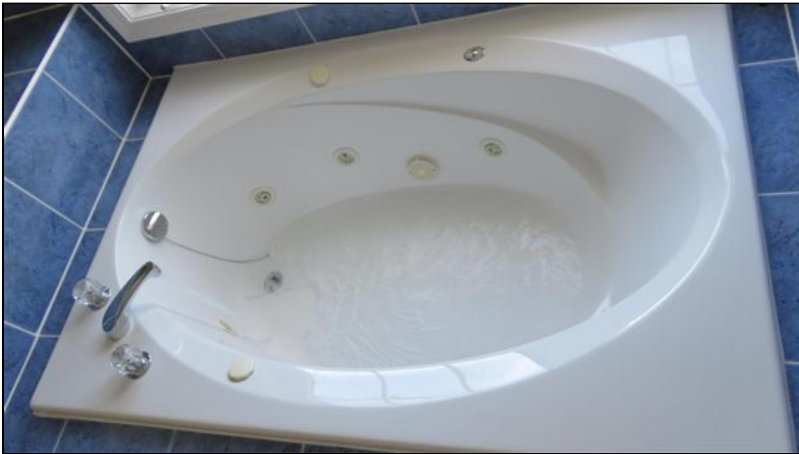
7.5 Jacuzzi tub was not in working condition,when tested. Recommended to be fixed.

14. Jacuzzi tub was not in working condition,when tested. Recommended to be fixed.

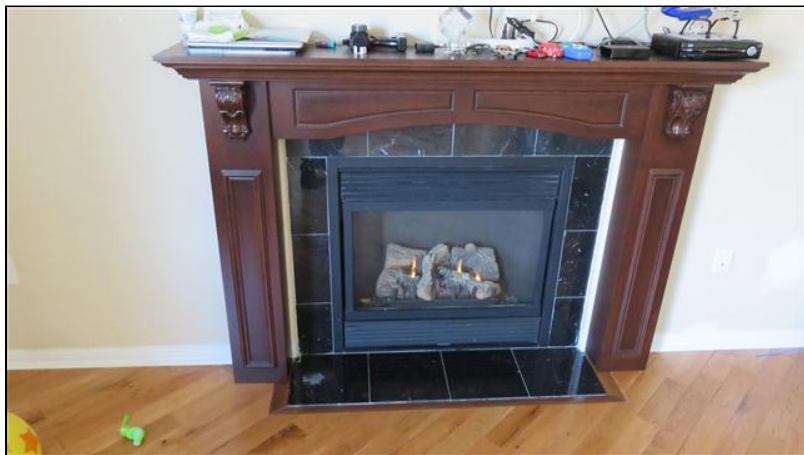
8.6 Gas fireplace installed in family room was functional, when tested.

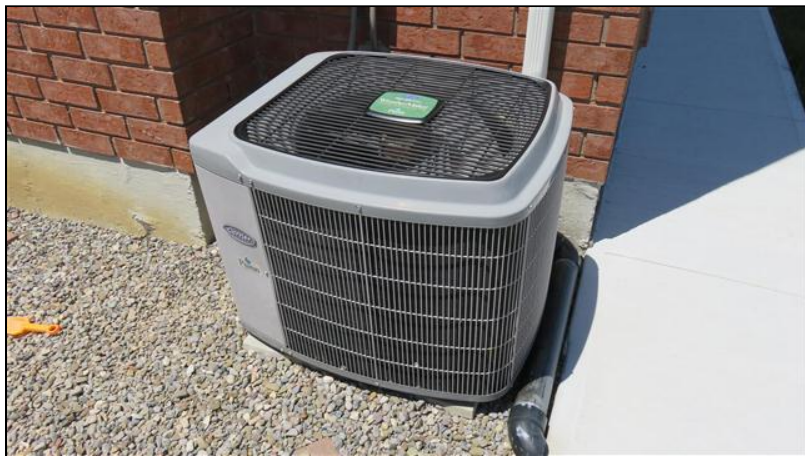
**8.8 Cooling system was already in use and in good working condition at the time of inspection.**
