Property Condition Assessment

Property Address:
1234 X Line
AnyCity, ON

Technominds Inspection Services Inc.

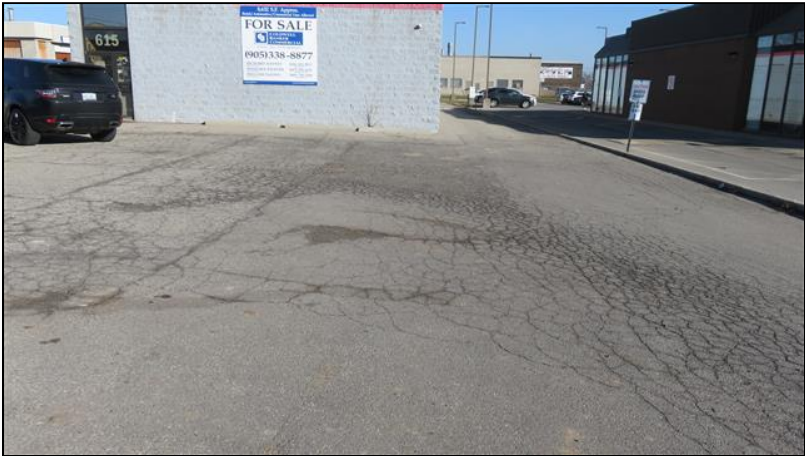
Front Parking Lot

Asphaltic pavement forms the parking area at the West and East side of the building. The drive aisles at the south sides of the building. The parking lot and driveway at front and back were in poor condition with shrinkage cracks and potholes. The asphalt pavement is aging and renewal is expected shortly.

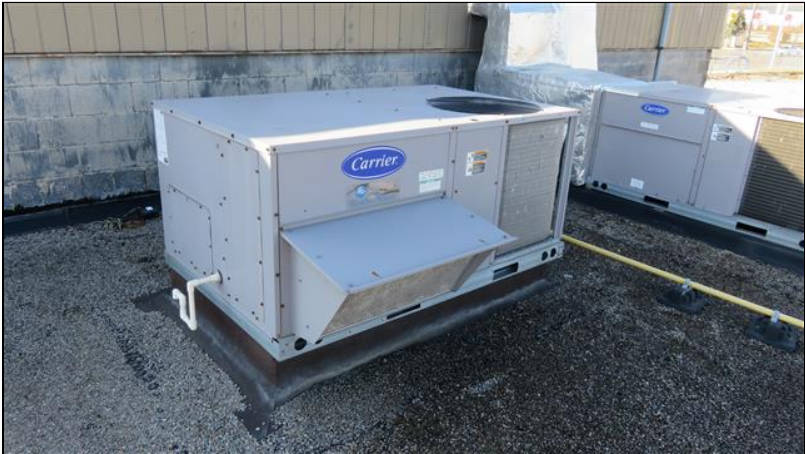
Roof Top Units

9.0 Heating & Cooling General Condition: The office areas are heated and air conditioned by roof-mounted, gas-fired, heating (electric cooling) units. The heat output of these units is 115,000BTUs per hour. The refrigerant used in the air-conditioning systems older than six years was identified as R-22. The new units less than six years has R-410A as per modern day standards.

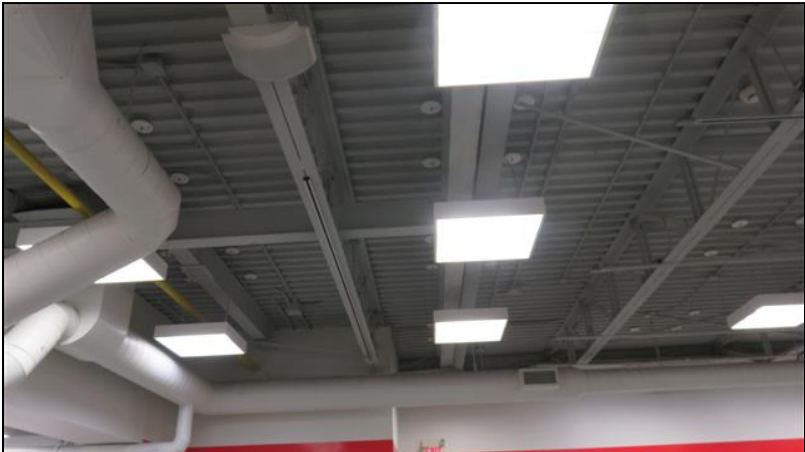
Radiant Heating

9.4 Two Radiant gas heaters not in working condition, thermostats not working when tested, in workshop area.
Recommended to be fixed or replaced as required.
